Lothar Sieber, Pilot of the "Natter" Ba 349A M23 ⁽¹⁾

Lothar Sieber World`s First Rocket Pilot

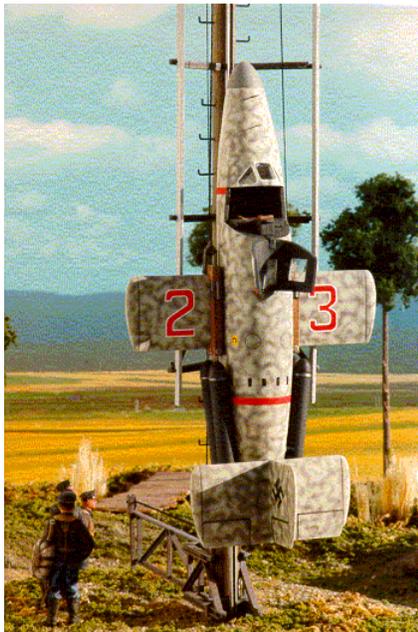
Bachem BA 349 "Natter" (Ref. 2)

White guiding rails and strap-on rockets
